Debris/Ice/TPS Assessment and Integrated Photographic Analysis of Shuttle Mission STS-67

Gregory N. Katnik, Barry C. Bowen, J. Bradley Davis

Technical Memorandum 110651

April 1995

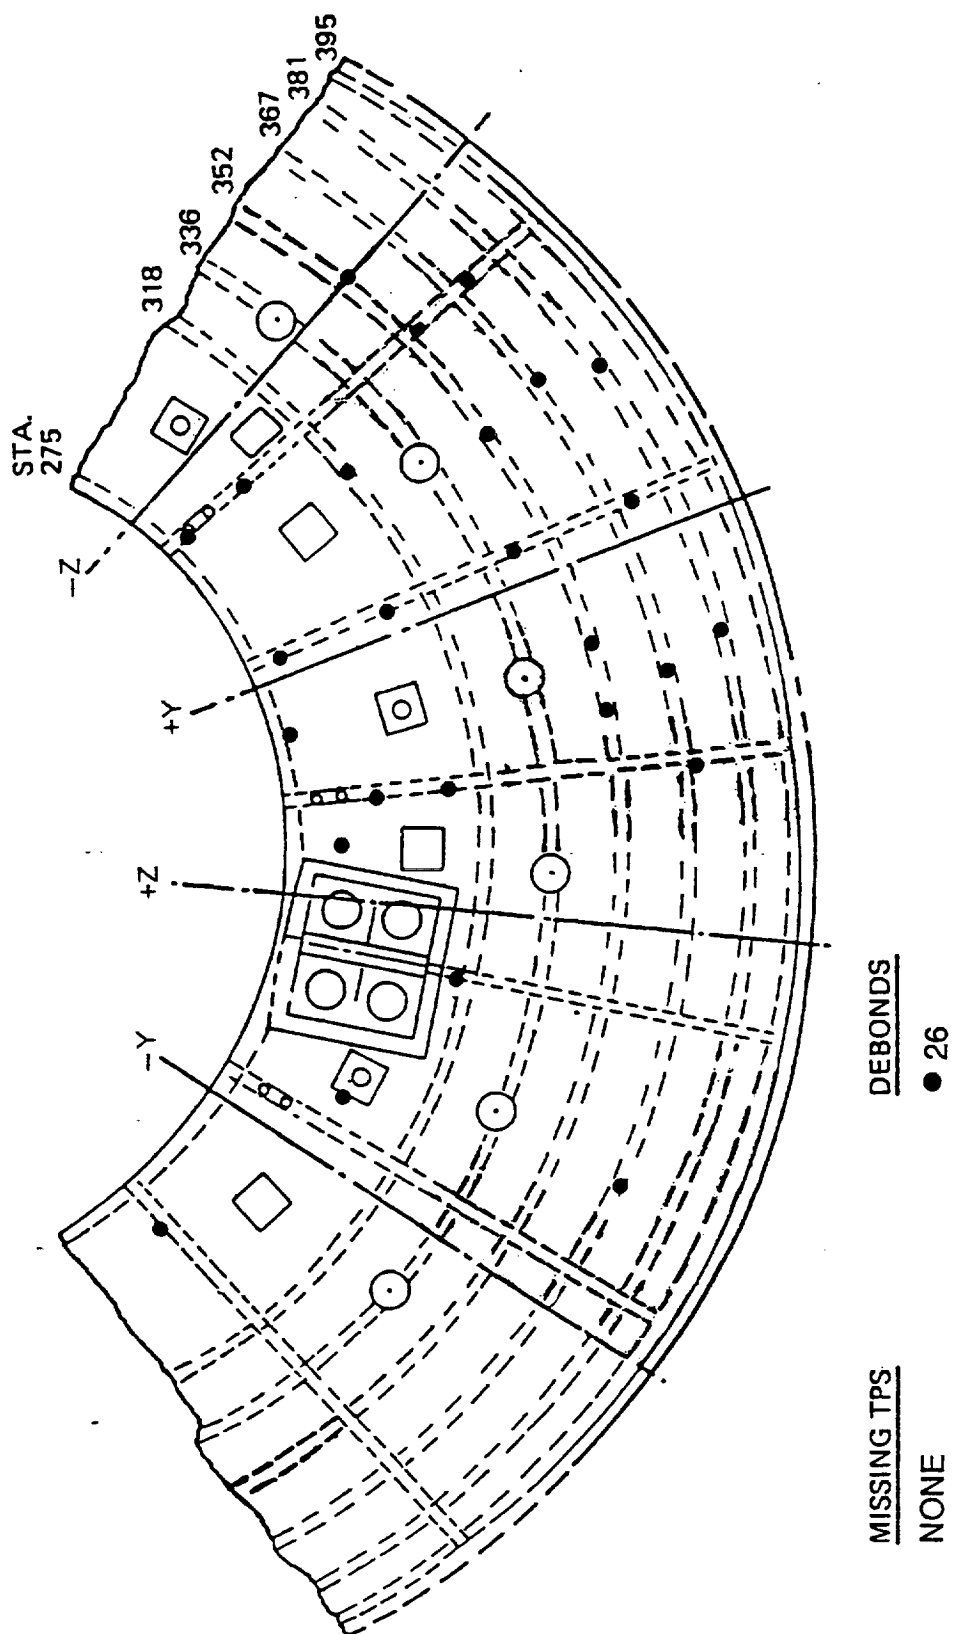
Figure 1 : RH SRB Frustum

The RH frustum was missing no TPS (Figure 1). The number of debonds over fasteners was average. Hypalon paint was blistered/missing along the XB-395 ring frame where BTA had been applied. Some of the underlying BTA was sooted. The BSM aero heat shield covers had locked in the fully opened position.

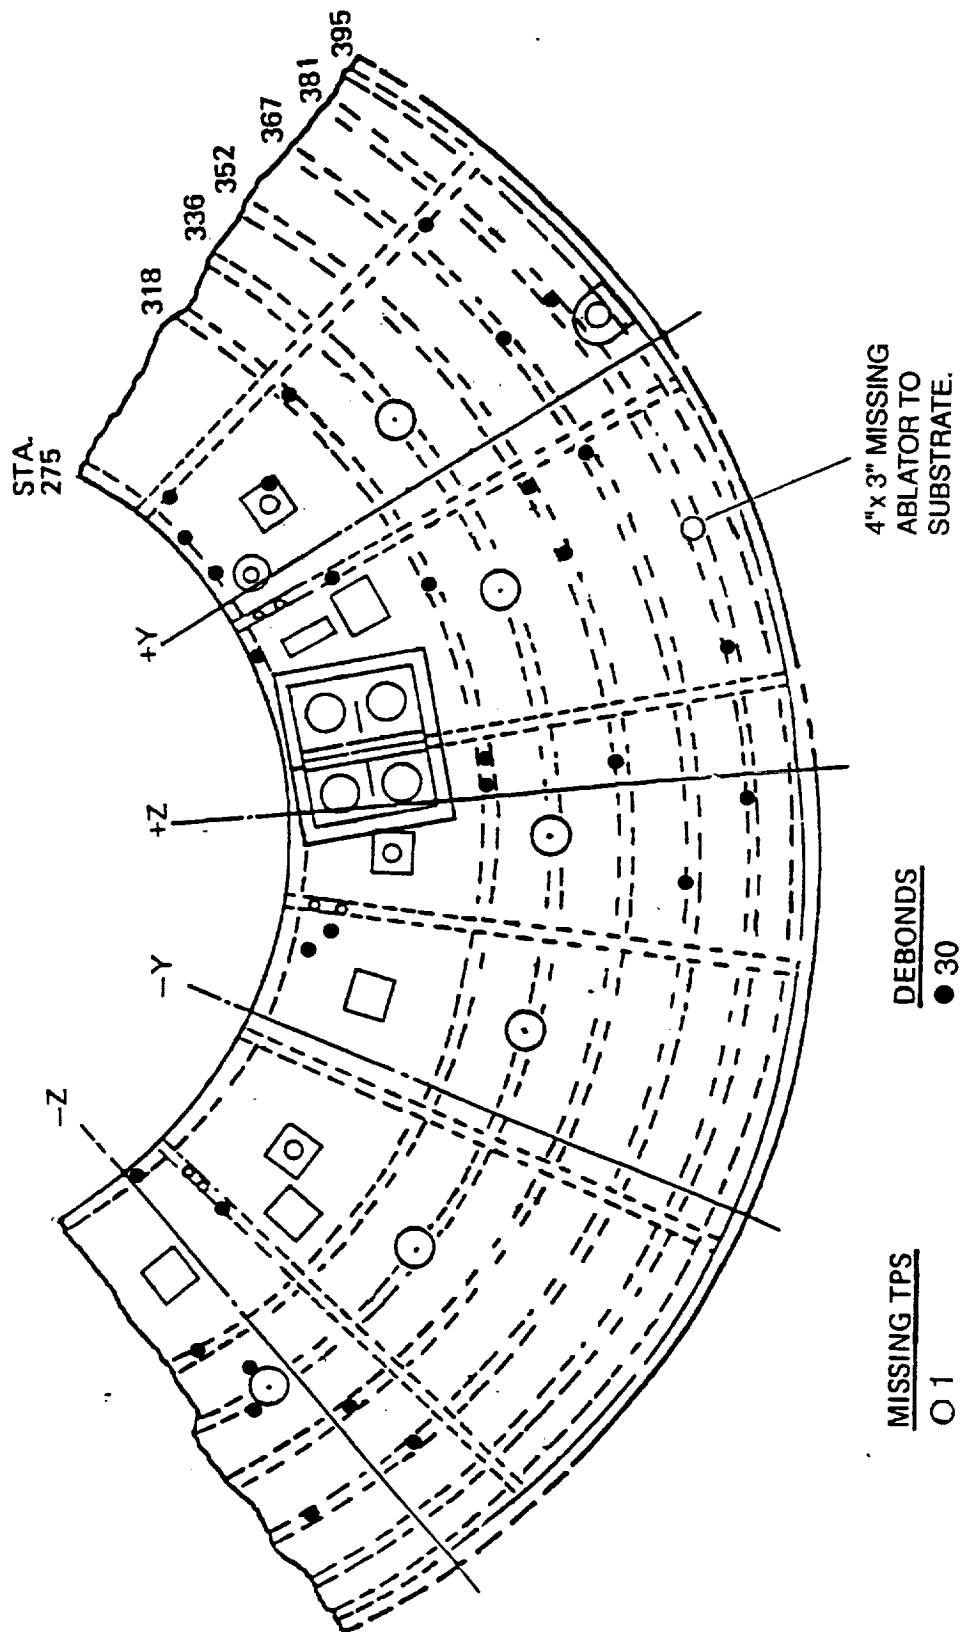
Figure 2 : LH SRB Frustum

The LH frustum was missing one 4-inch by 3-inch piece of TPS over three fasteners on the XB-381 ring frame between the +Y/+Z axes. The exposed substrate did not appear sooted. The number of MSA-2 debonds over fasteners was average (Figure 2). Hypalon paint was blistered/missing along the XB-395 ring frame where BTA had been applied. Some of the underlying BTA was sooted. The BSM aero heat shield covers had locked in the fully opened position.

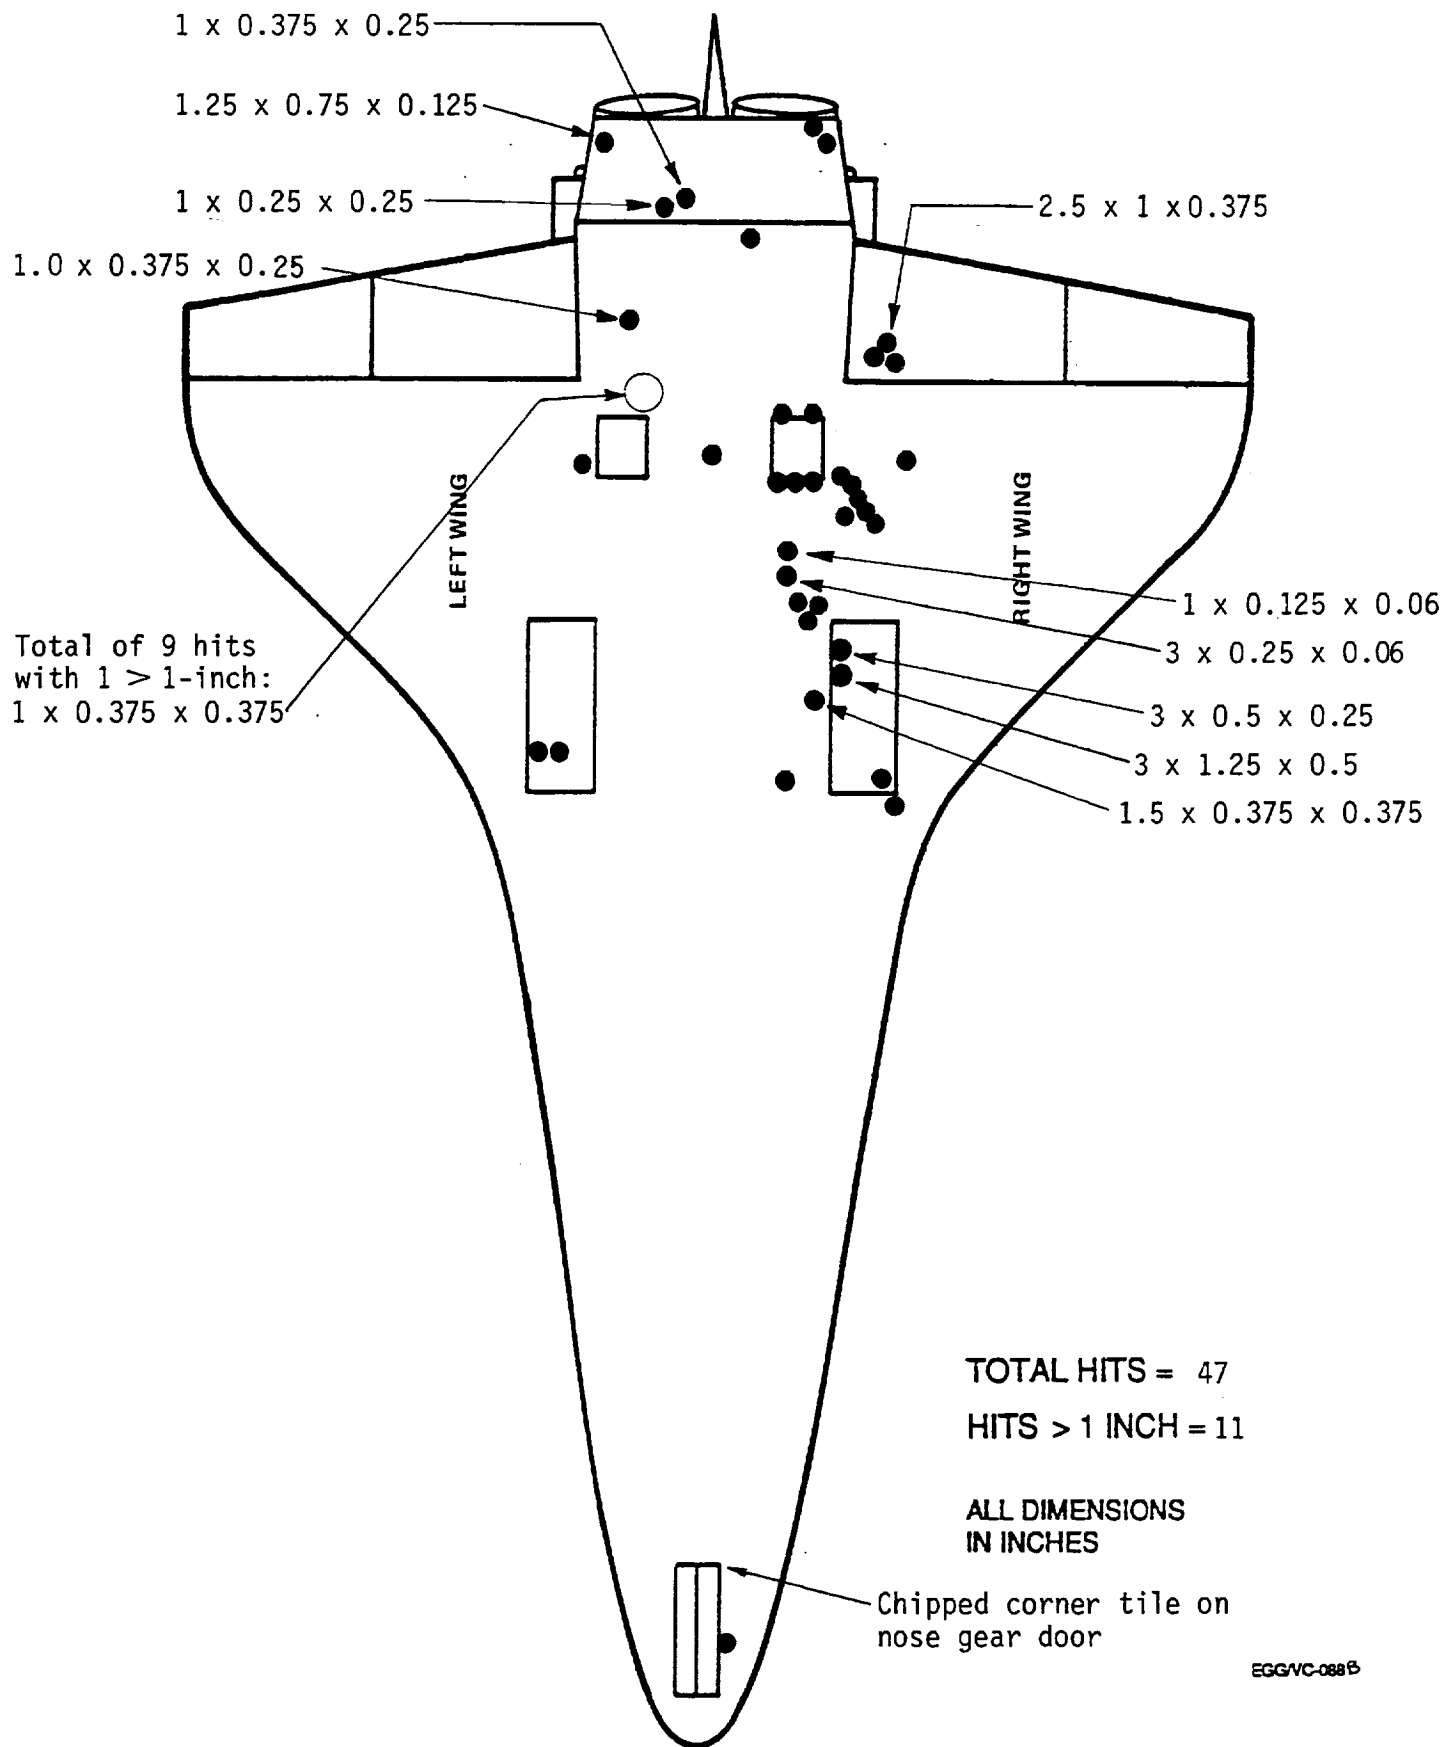
Figure 3 : Orbiter Lower Surface Debris Map

In summary, both the total number of Orbiter TPS debris hits and the number of hits 1-inch or larger was less than average when compared to previous missions (Figures 7-8). From a debris standpoint, the total number of hits was the lowest in the last 30 flights. The type of TPS damage was typical and not attributable to any single debris source.

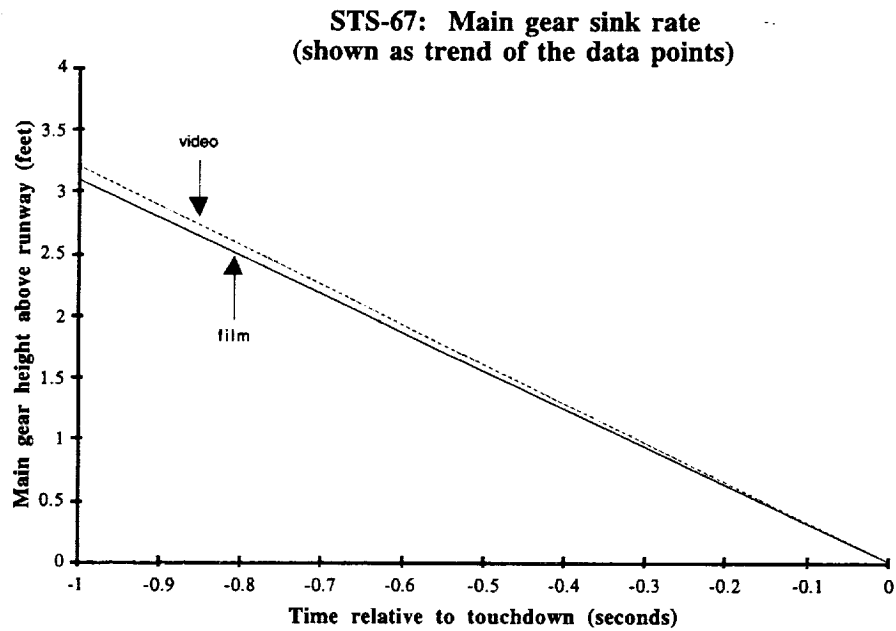
Figure 2.5.1 (A): Main Gear Sink Rate from Film (E1035) and Video (LRO2)

The measured main gear and nose gear sink rate values were found to be below the maximum allowable values of 9.6 ft/sec for a 211,000 lb. vehicle and 6.0 ft/sec for a 240,000 lb. vehicle (the landing weight of the STS-67 Orbiter was reported to be 217,450 lb.). The sink rate measurements for the STS-67 are given in Table 2.5.1. In Figures 2.5.1 (A) and 2.5.1 (B) the trend of the measured data points for both film camera image data and video image data are illustrated.
